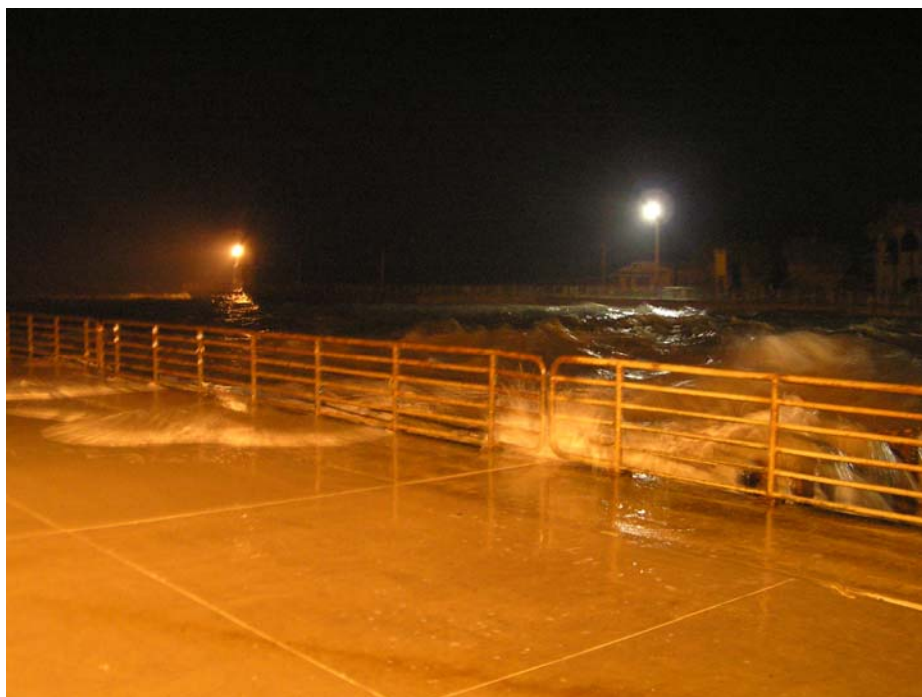
Over-wash at Rollover Pass approximately 30 hours prior to Hurricane Ike's landfall. Photograph taken at approximately 9:30 pm CDT, September 11, 2008. Photograph by Ian Giammanco.

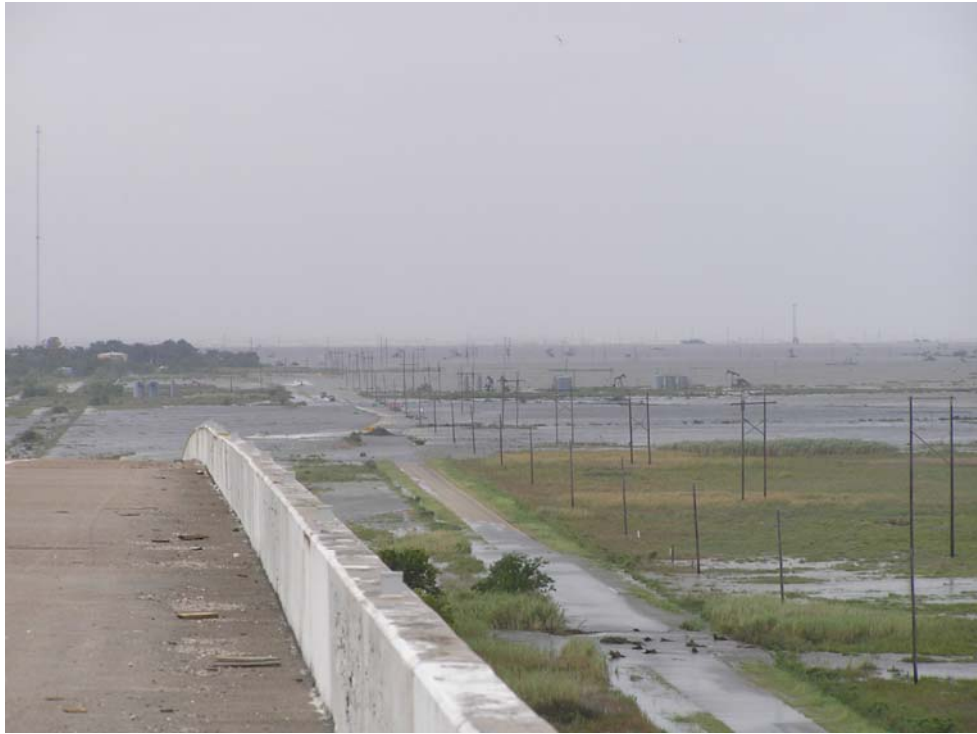
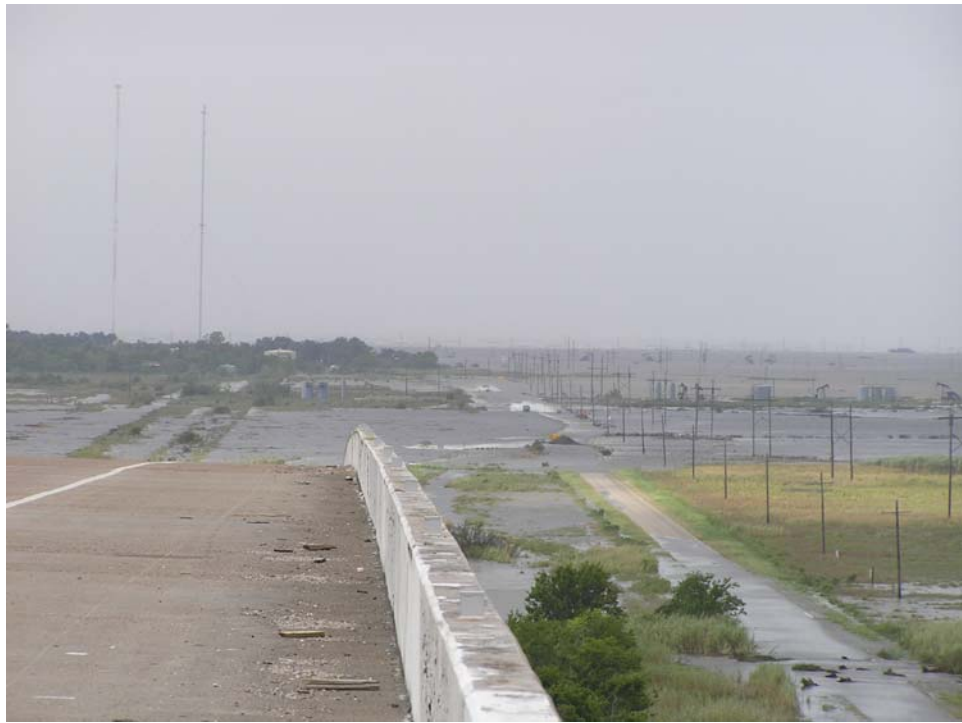
Photographs (above and below) taken September 12, 2008 at approximately 10:00 am CDT. Photo is looking south-southwest toward the Bolivar Peninsula. High Island is visible on the left side of the image. Photographs by Tanya Brown.

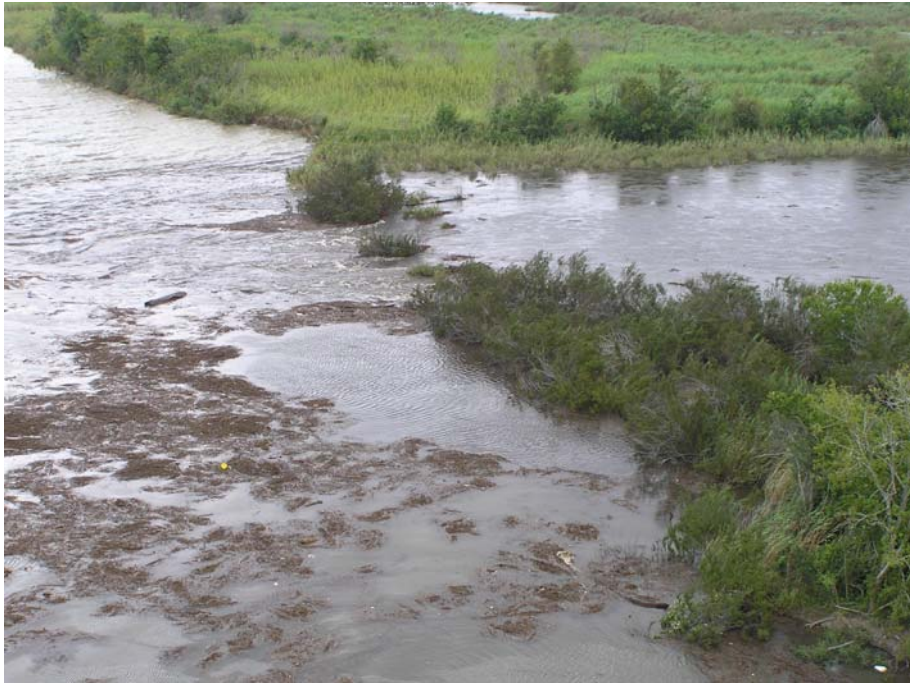
Initial storm surge flooding into the marshland near the Intracoastal waterway north of High Island, Texas. Photograph was taken at 10:00 am CDT September 12, 2008. Photograph by Ian Giammanco

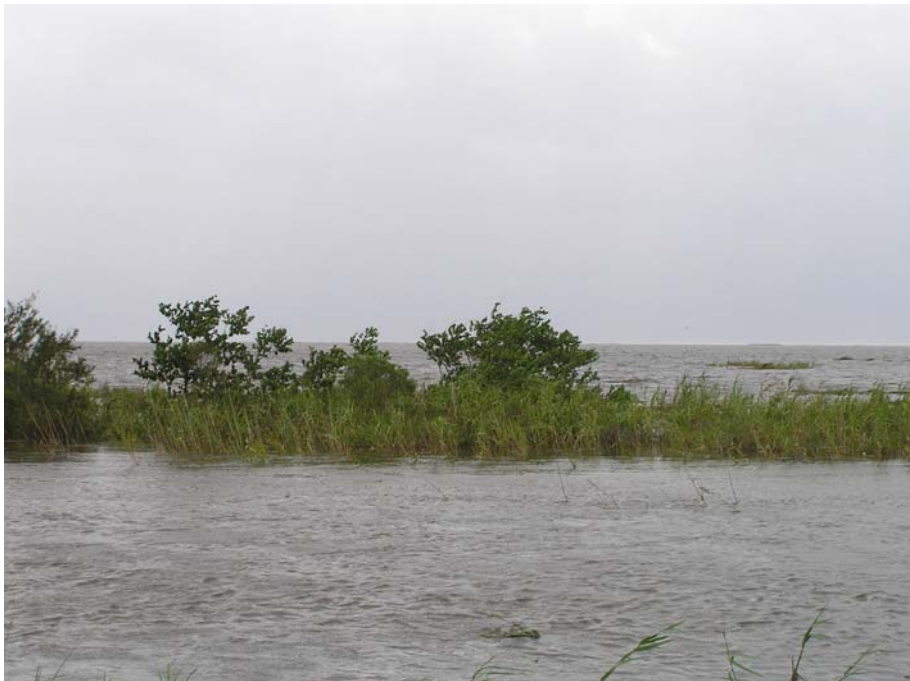
Water approaching SR 124 just north of High Island TX. Photograph taken at 10:30 am CDT September 12, 2008. Photograph by Ian Giammanco

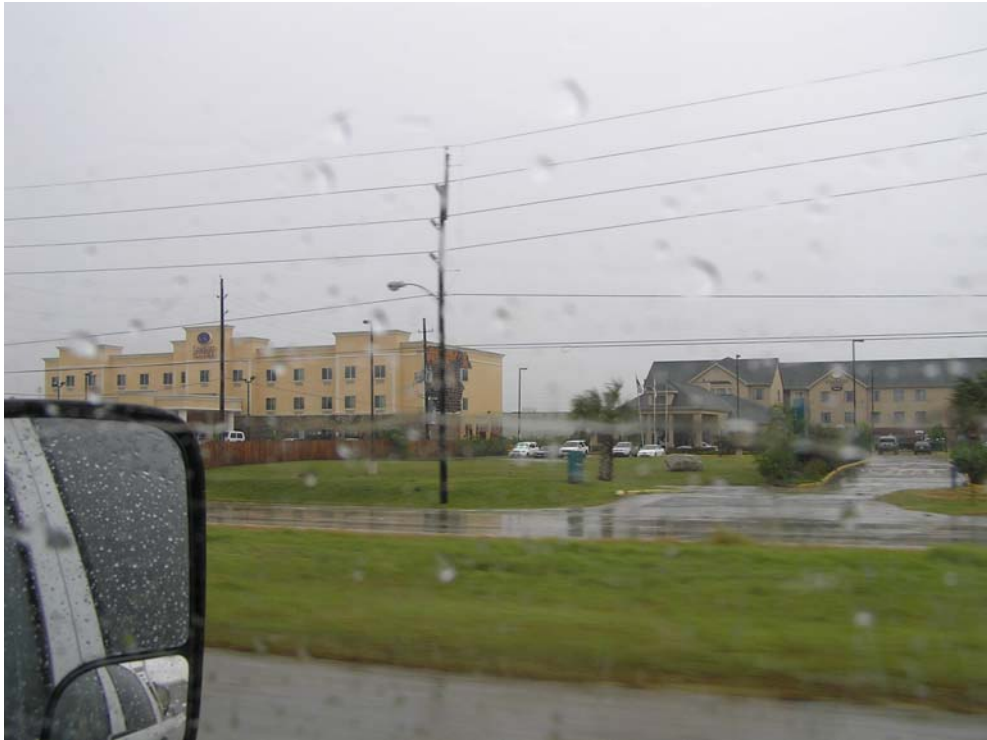
Hotel siding damage east of Houston. Photograph taken 9:00 am CDT September 14, 2008. Photograph by Tanya Brown.

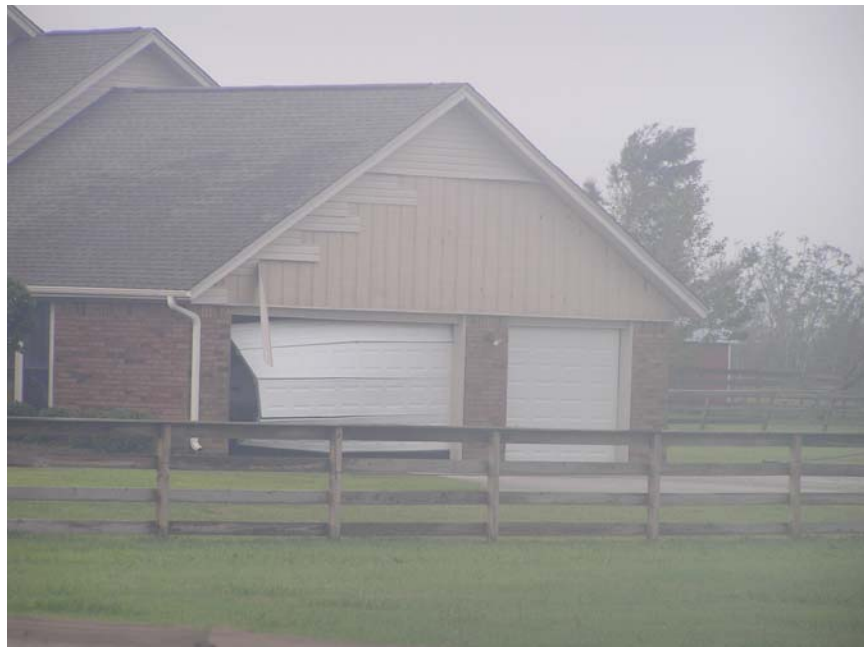
Garage door and siding damage to a home near Winnie, TX. Photograph taken 2:00 pm CDT September 14, 2008. Photograph by Tanya Brown.

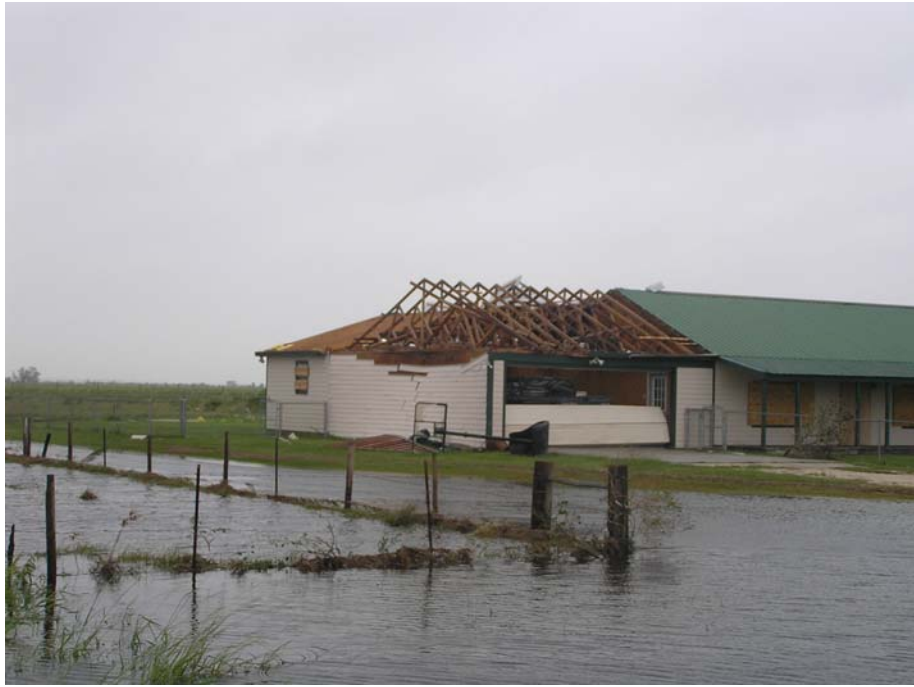
Roof decking loss and garage door failure near Winnie, TX. Photograph taken 3:00 pm September 14, 2008. Photograph by Tanya Brown.

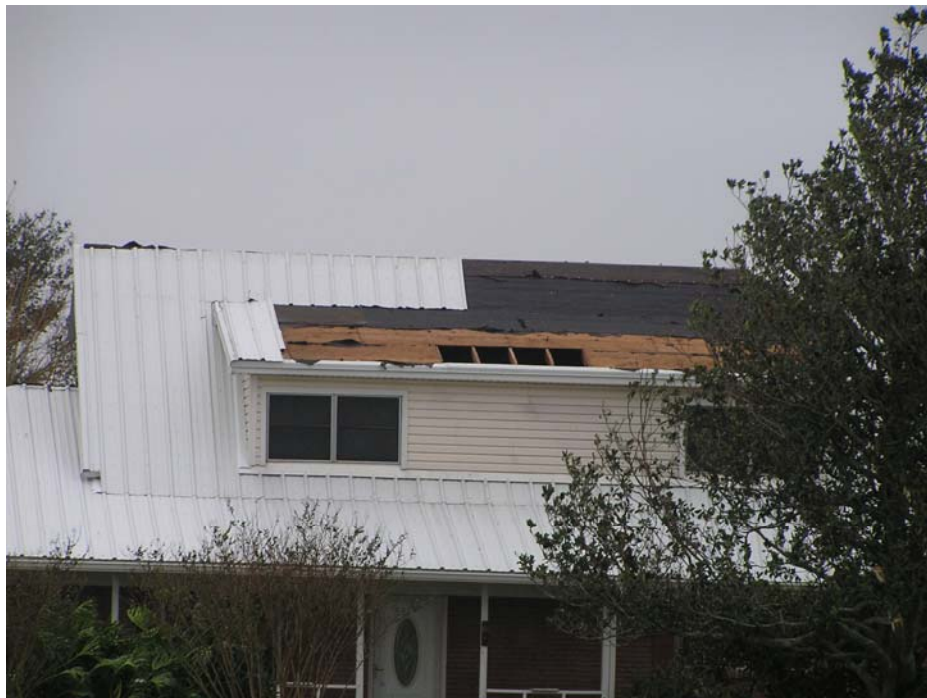
Roof decking loss and metal roof loss in Winnie, TX. Photo was taken looking north at the south facing front of the residence. Photo was taken during the afternoon of September 14, 2008. Photograph by Tanya Brown.

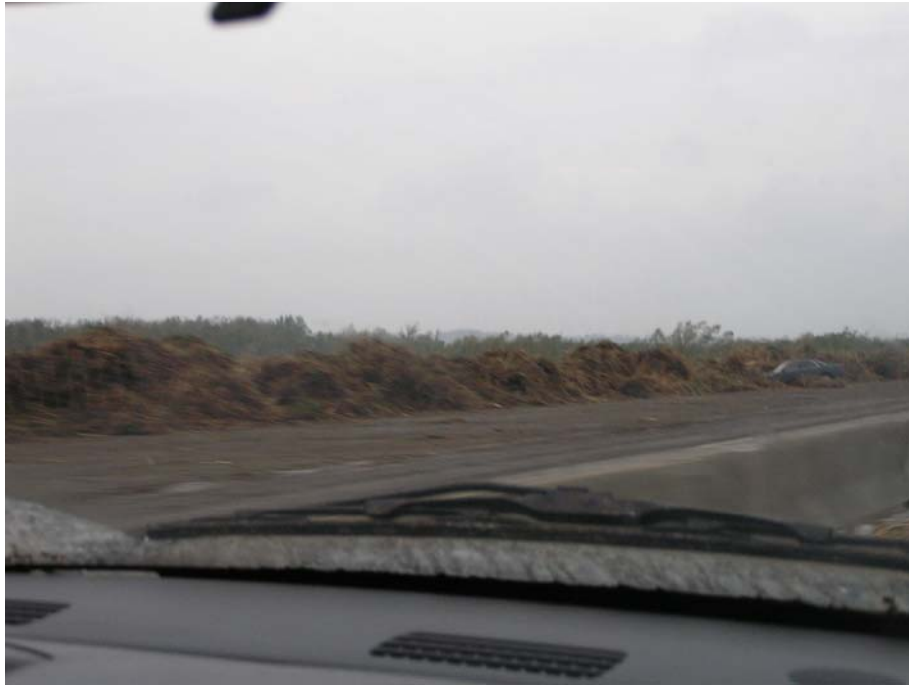
Debris along Interstate – 10 near Channelview, TX. Photo was taken during the evening of September 15, 2008. Photograph by Tanya Brown.

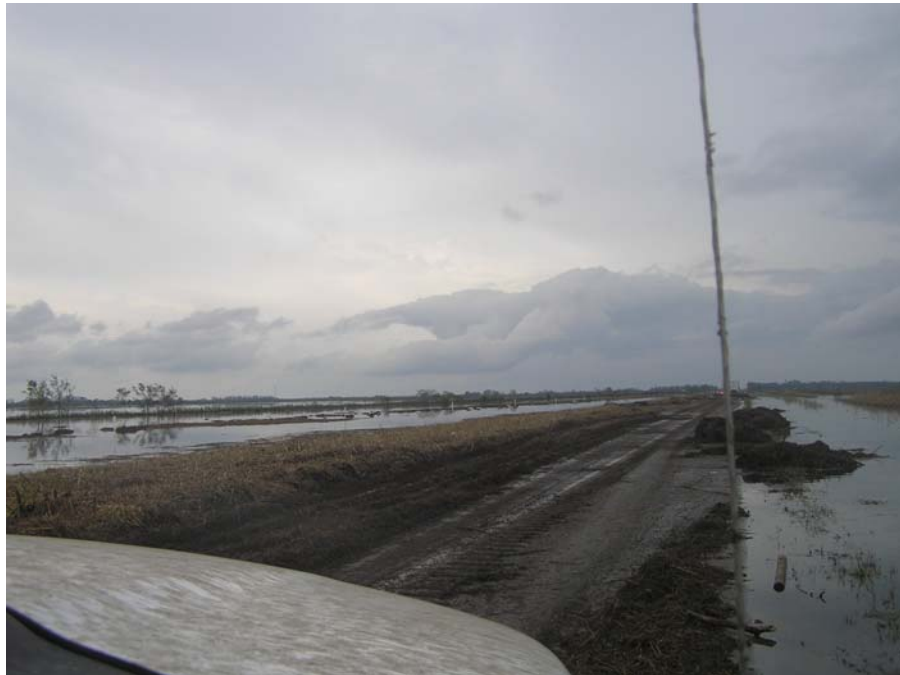
Debris from storm surge flooding along SR 73 east of Winnie, TX. This location was approximately 15 miles inland. Water was also noted well north of SR 73 and had covered the road. Photograph taken during the afternoon on September 15, 2008. Photograph by Tanya Brown

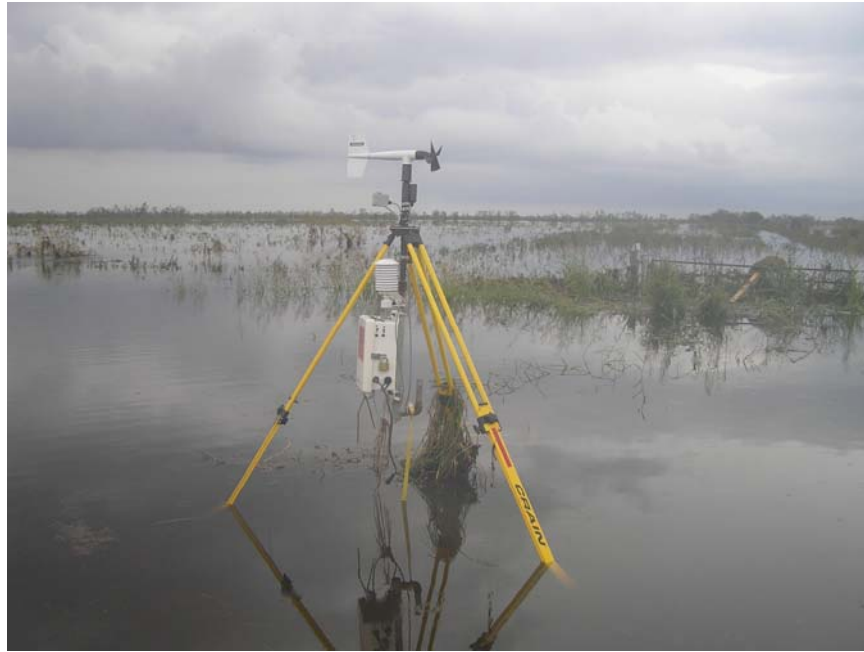
Photo of probe 0105A 6 miles east of Winnie, TX along SR 73. It appeared that the probe was experienced approximately 3.5 ft of storm surge flooding. At the time of retrieval approximately 1.5 ft of water was still over the feet of the probe. The probe functioned properly and collected a complete data record through the peak of Hurricane Ike. Photograph was taken during the afternoon on September 15, 2008 by Tanya Brown.

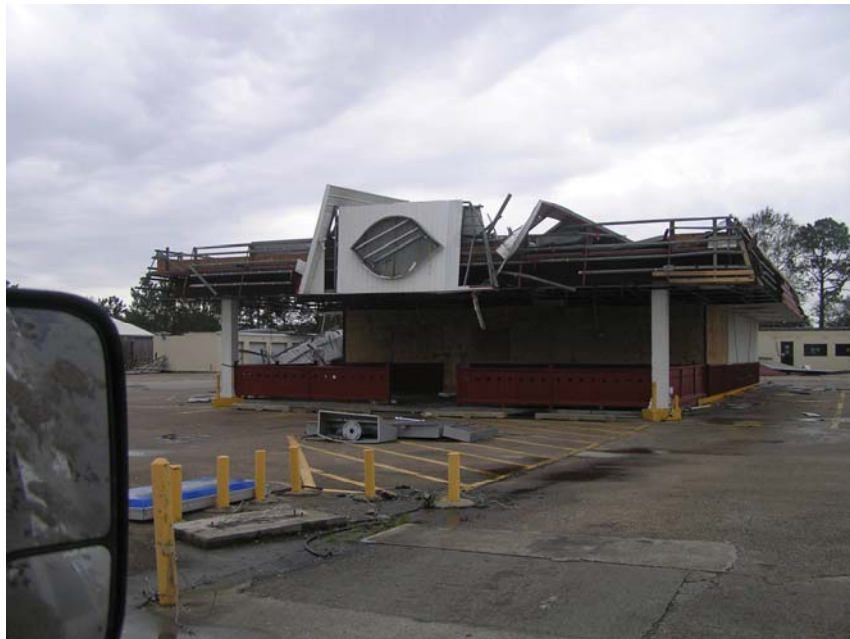
Damage to a Dairy Queen in Winnie TX. Photograph was taken on the afternoon of September 15, 2008 by Tanya Brown.

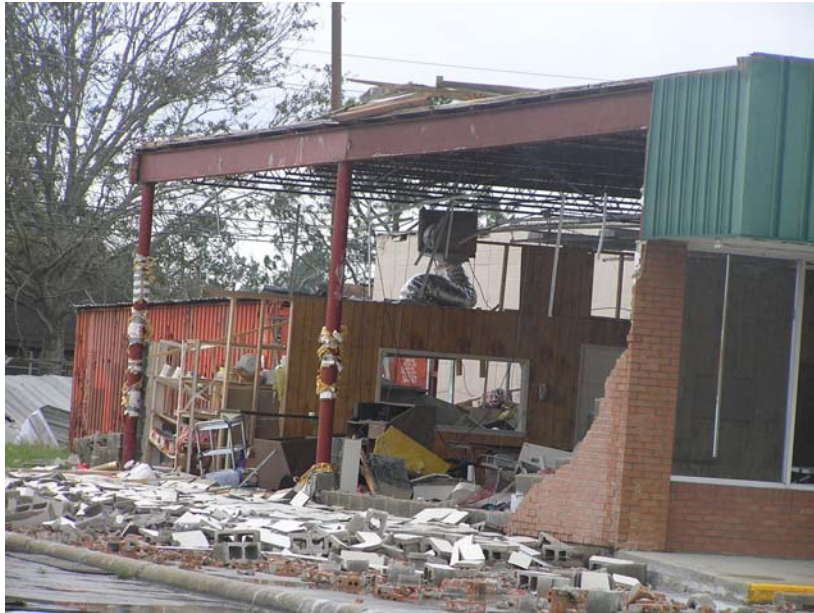
Damage to a structure adjacent to the Dairy Queen in the previous photo. Note the unattached brick/cinderblock façade. Photograph taken on the afternoon of September 15, 2008 by Tanya Brown.

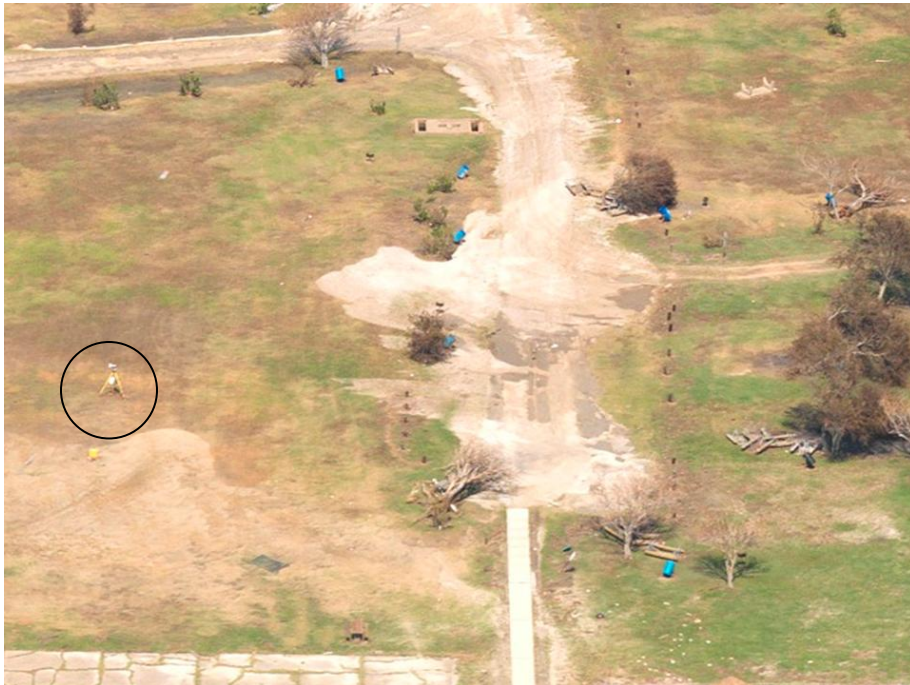
Aerial photograph of Probe 0110A (circled) on the grounds of Ft. Travis on the western end of the Bolivar Peninsula. Even though the area was inundated with approximately 2 ft of storm surge (which overtopped the fort's seawall of 17 ft.) the probe continued to operate collecting data for seven and a half days. Photograph courtesy of ABS Consulting.

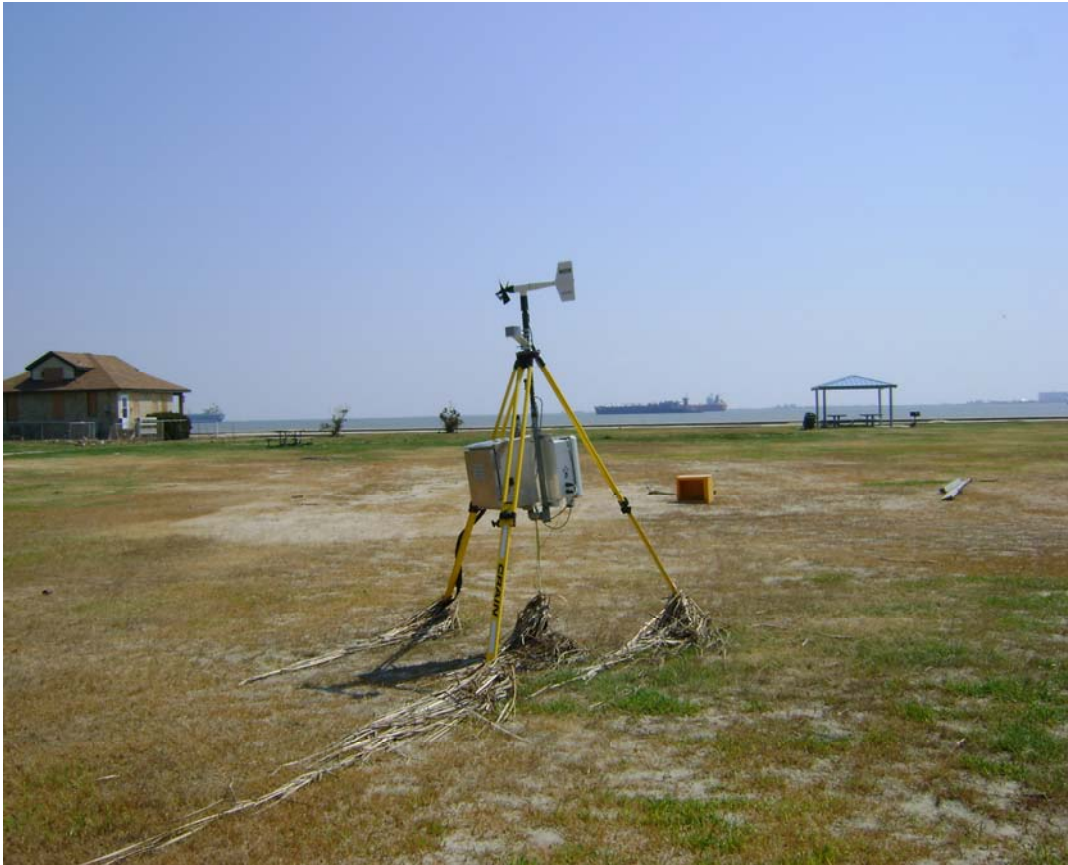
Photograph of Probe 0110A on the grounds of Fort Travis at the western tip of the Bolivar Peninsula. The picture was taken nearly three weeks after the probe was deployed in advance of Hurricane Ike. The probe collected a complete data record. The plot can be seen in the data plots section on our [Hurricane Ike](#) page. Special thanks to Lee Lockwood and John Lee of the Galveston County Emergency Management Office for retrieving the probe. Photograph taken by John Lee and Lee Lockwood.

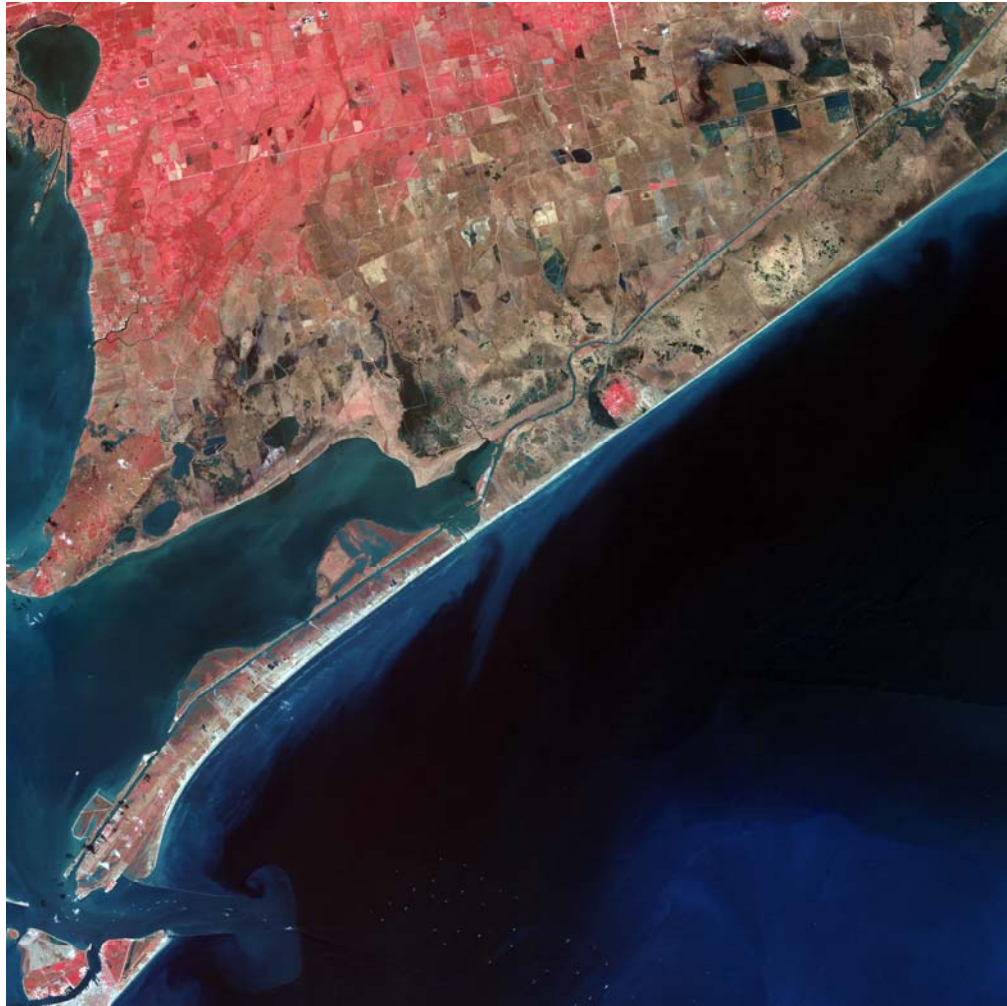
Landsat image of the Bolivar Peninsula and southern Chambers Co. following Ike. The false color imagery shows active vegetation in red. Areas which were inundated by storm surge flooding are shown in brown as vegetation was killed by salt water intrusion. The isolated red area just right of the center of the image is High Island, TX. Image courtesy of NASA.
